Jacquelyn coating (U.S. Patent #5,945,171) is a copper nickel metal coating used to prevent bio fouling. The coating process produces a strong bond to the substrate and the copper alloy does not rely on copper leach. Because of this, Jacquelyn is a superior solution when compared to copper nickel construction. In bio fouling-infested waters, the Jacquelyn-coated object remains free of zebra mussel attachment.

JACQUELYN COATING

CASE STUDIES

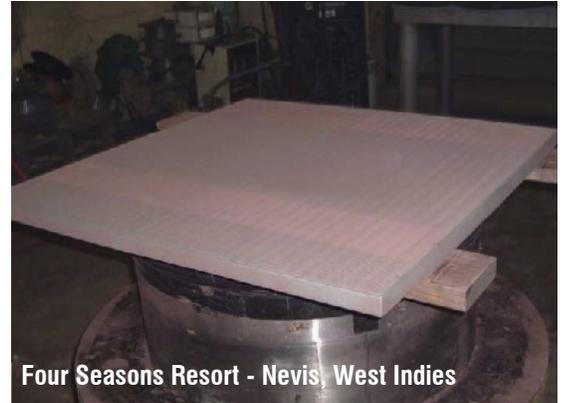
Coating for chiller strainer in the tropics

Bio fouling was an issue at an island resort. Elgin worked with the resort owner to retrofit his existing intake system (an offshore strainer) with a new passive screen system. Elgin worked with the site owner to develop a custom flow modifier within the system to ensure consistent flow, and to make the screens so they could be easily installed and removed. To address bio fouling concerns Elgin coated the screens with Jacquelyn Coating.

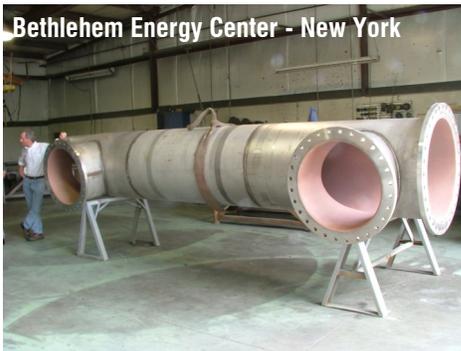
Coating for intake pipe at power plant

A power plant was retrofitting its cooling water intake system to comply with EPA Regulation 316(b). Concerns arose because the water body was infested with zebra mussels. In addition, the flow rate through the system was going to be decreased to a flow rate optimal for zebra mussel growth. The facility needed to maintain ample cooling water to avoid costly thermal discharge penalties or a system outage. Jacquelyn coating was used to address these concerns. Our team built the pipe and applied Jacquelyn coating to the ID of the pipe array. This application led to a significant reduction in capital cost over the use of exotic material such as 90-10 CuNi for the piping.

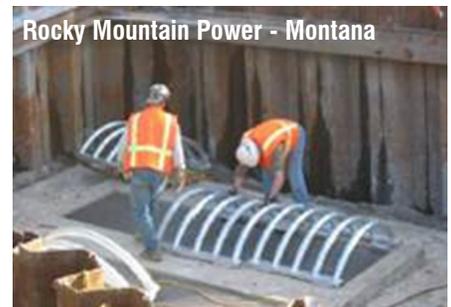
Coating for flat panel screens at hydro plant

A small hydroelectric plant in Montana was inundated with bio fouling problems. To protect their system, they retrofitted their existing structure with an array of flat panels coated with Jacquelyn coating. Elgin provided a solution that simply worked.
